Case Study No. 23 Waterborne Coatings
Shafer Commercial Seating
Denver, CO

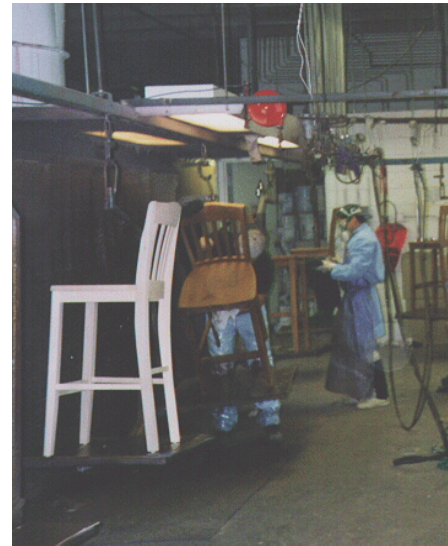
Shafer has one coating line. During the day shift, chairs are coated. Table tops and a smaller number of chairs are coated during the night shift. The chairs move along the coating line on pallets that hang from an overhead conveyor system. The table tops are fastened to vertical bars that hang from the overhead conveyor. The line travels at about 6 feet per minute.

Coating line

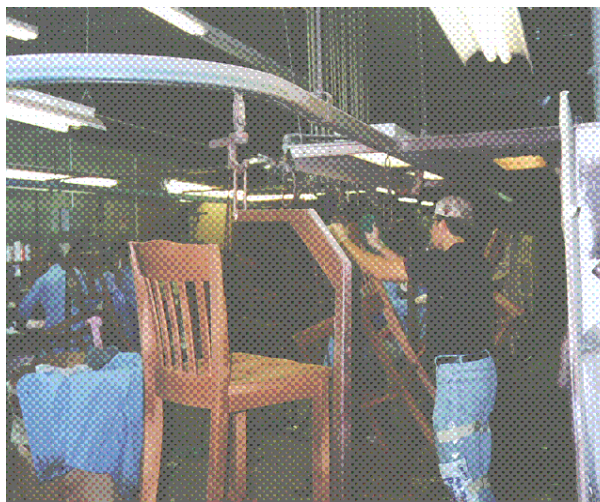
The sealer then is applied using airless spray guns. The facility found that this type of gun allows them to apply more sealer than an air-assisted airless gun. The chair then passes through a second IR oven and makes two passes through cooling air. Next, the chairs are taken off the line, one at a time, and placed in a machine that uses ceramic beads to polish, or “pound in,” the sealer. Before Shafer started using this machine, the operators would sometimes sand through the sealer in an attempt to control the grain raise caused by the waterborne coatings. The chairs are lightly sanded by hand and any dust is wiped off before the topcoat is applied.

Sealer application

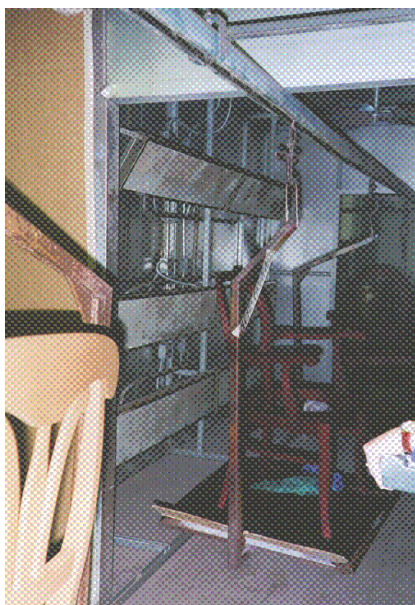
IR oven

Shafer's largest obstacle in making the waterborne system work has been the waterborne stains. They have had problems with dry time, excessive grain raise, and color consistency. At first, the water in the new stain would evaporate before they could wipe the stain. The coating supplier reformulated the stain to prevent this problem. Shafer would like to be able to take the chairs off the coating line after the stain application to allow for more drying time, but their current space does not allow that. If the stain is not dry before additional coatings are applied, the topcoat does not perform as well. Therefore, they have increased the IR oven air circulation and temperature, and added fans above the line to further aid in drying.
